The New Construction Inspection

NEW CONSTRUCTION: INSPECTION REPORT

Concerning: NEW HOME ADDRESS

The subject home is a “new” two-story single family wood frame structure, with an attached garage. The exterior siding consists of brick veneer and cement-composite type fiberboard. The roof substructure is a hip type, purlin braced, and covered with OSB sheathing overlain by composition shingles. The foundation appears to be a post tensioned, “slab-on-grade” configuration.

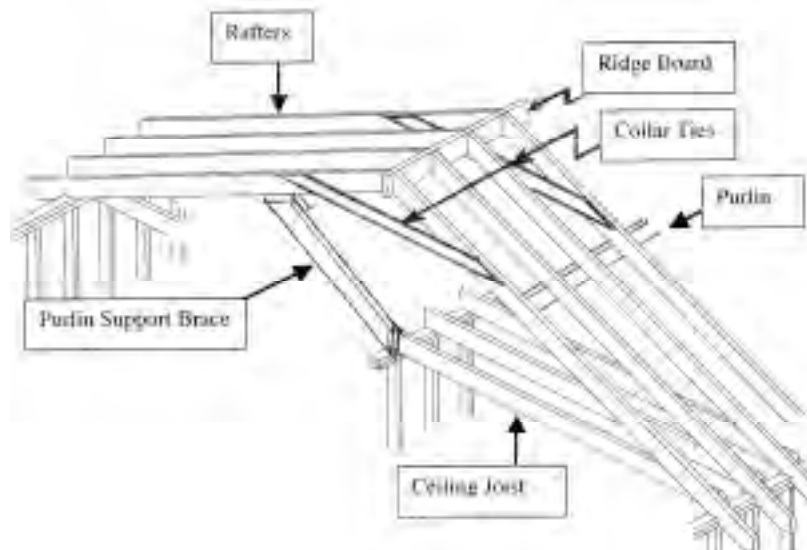
See following drawing for description of common framing members.

1) There were visible depressions (noticeable "sagging" effect) at the front pitch roof surface. This condition appeared to be caused by a combination of excessive horizontal rafter span conditions (14'-6" in one area) and the use of spliced rafters (see #2 following), additional bracing will be required to properly support the rafters (purlin bracing; see following drawing). The 2003 IRC building code (Table R802.5.1; Rafter Spans For Common Lumber Species) indicates that the maximum horizontal span for a 2"x6" rafter (#3 SYP) is 10'8" when rafter spacing is 19.2" O.C.

2) There were several spliced rafters used in the roof substructure construction, at both the front and rear pitch rafters. While some of the spliced rafters were supported with purlin bracing in the area of the "overlap", several rafters were not supported with bracing in the area of the splice. It is recommended that support bracing and/or additional reinforcement framing be added at the spliced ("overlap") areas.

3) The rear pitch roof surface was not visible from ground level, and the attic space in this area was not safe for access (due to insulation coverage). However, similar excessive horizontal rafter span conditions appeared to be present (14'+ in one area), additional bracing will be required to properly support the rafters in this area.

Design of roof framing modifications is beyond the scope of this report; therefore, it is recommended that the builder evaluate and add additional support bracing and/or reinforcement framing in the above identified areas. Structural modifications should be based upon currently accepted (2003 IRC) construction practices for minimum roof framing.
